# SUB-PROJECT COMPLETION REPORT

### RECONSTRUCTION OF ROADS & BRIDGES

#### VOLUME – I (ROADS)

### Reconstruction of Roads in Kashmir Division.

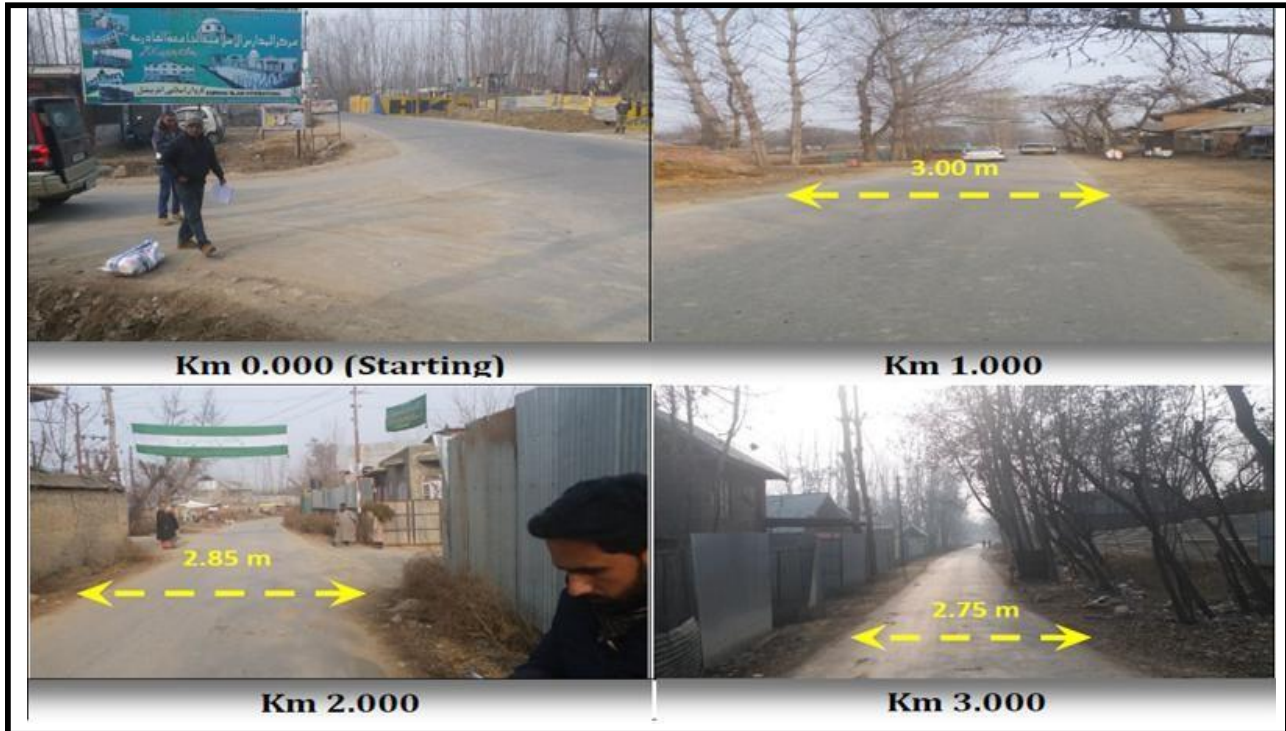
- **Pavement Condition:** The flexible pavement of the Shadipora-Kanipeth road was in fair to poor condition, with significant damage visible in several stretches. Rutting, cracking, and potholes are common, particularly in areas where maintenance had been inconsistent or poorly executed.
- **Carriageway & Shoulders:** The carriageway width varied from 2.5 meters to 3 meters, which was substandard for a single-lane road. The shoulder width was

approximately 1 meter, resulting in a formation width ranging from 4.75 meters to 5 meters.

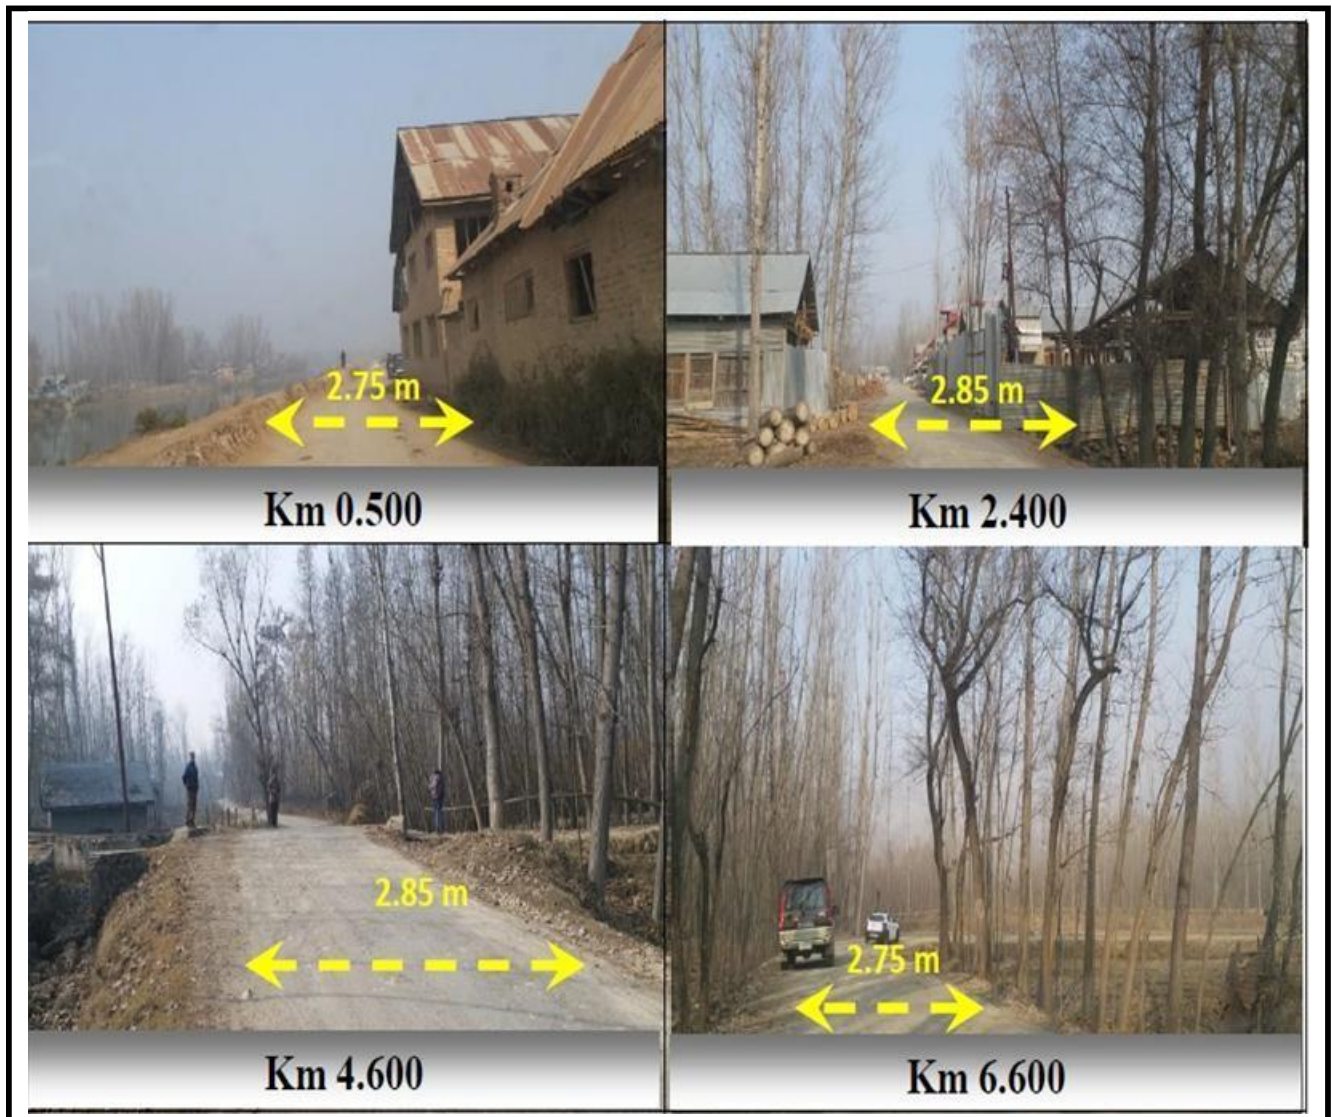
**widening and upgrades.** Like the other two roads, the **2014 floods** exacerbated the road's existing issues, damaging several sections and making it difficult to travel. The existing infrastructure, such as the cross-drainage structures, has been overwhelmed by siltation and flooding, requiring urgent attention.

- **Pavement Condition:** The existing pavement was a flexible type and was in very poor condition. There were signs of extensive longitudinal cracks, crocodile cracks, rutting, edge failure, and potholes throughout the stretch. Sections of the road had been patched with bituminous material, but the overall condition was still unsuitable for modern traffic.
- **Carriageway & Shoulders:** The carriageway width ranged from 2.75 meters to 2.95 meters, which was below the standard for an intermediate lane. The shoulder

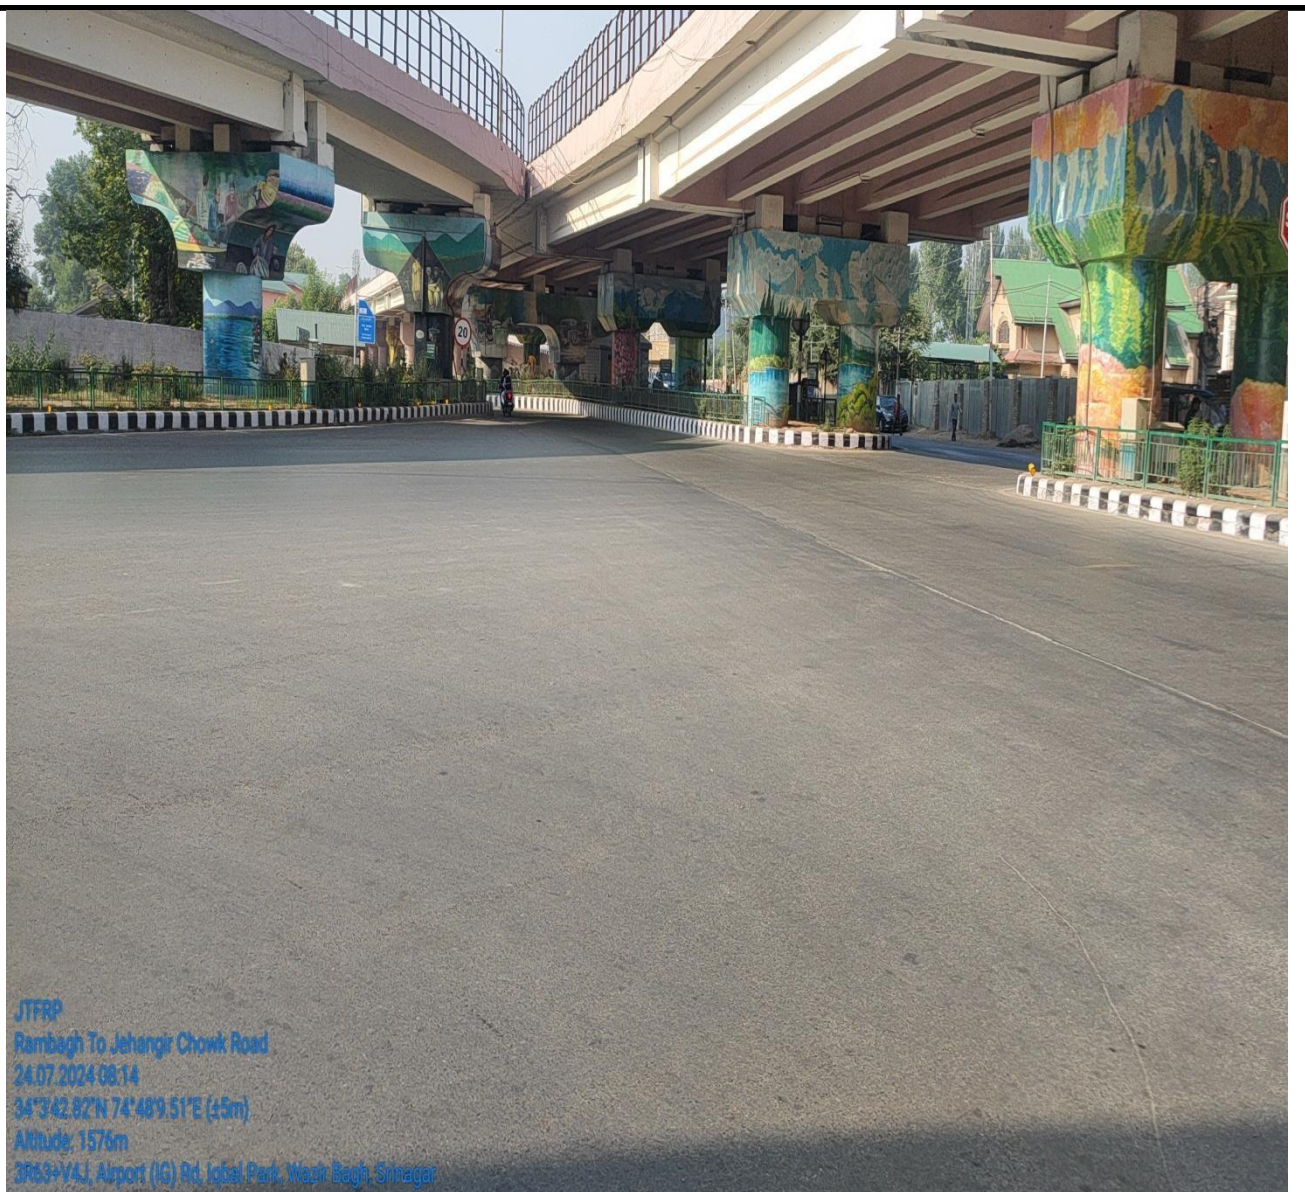
JTFRP  
Rambagh To Jehangir Chowk Road  
24.07.2024 08:14  
34°3'42.82"N 74°48'9.51"E (±5m)  
Altitude: 1576m  
3R63+V4J, Airport (IG) Rd, Jhelum Park, Wazir Bagh, Srinagar

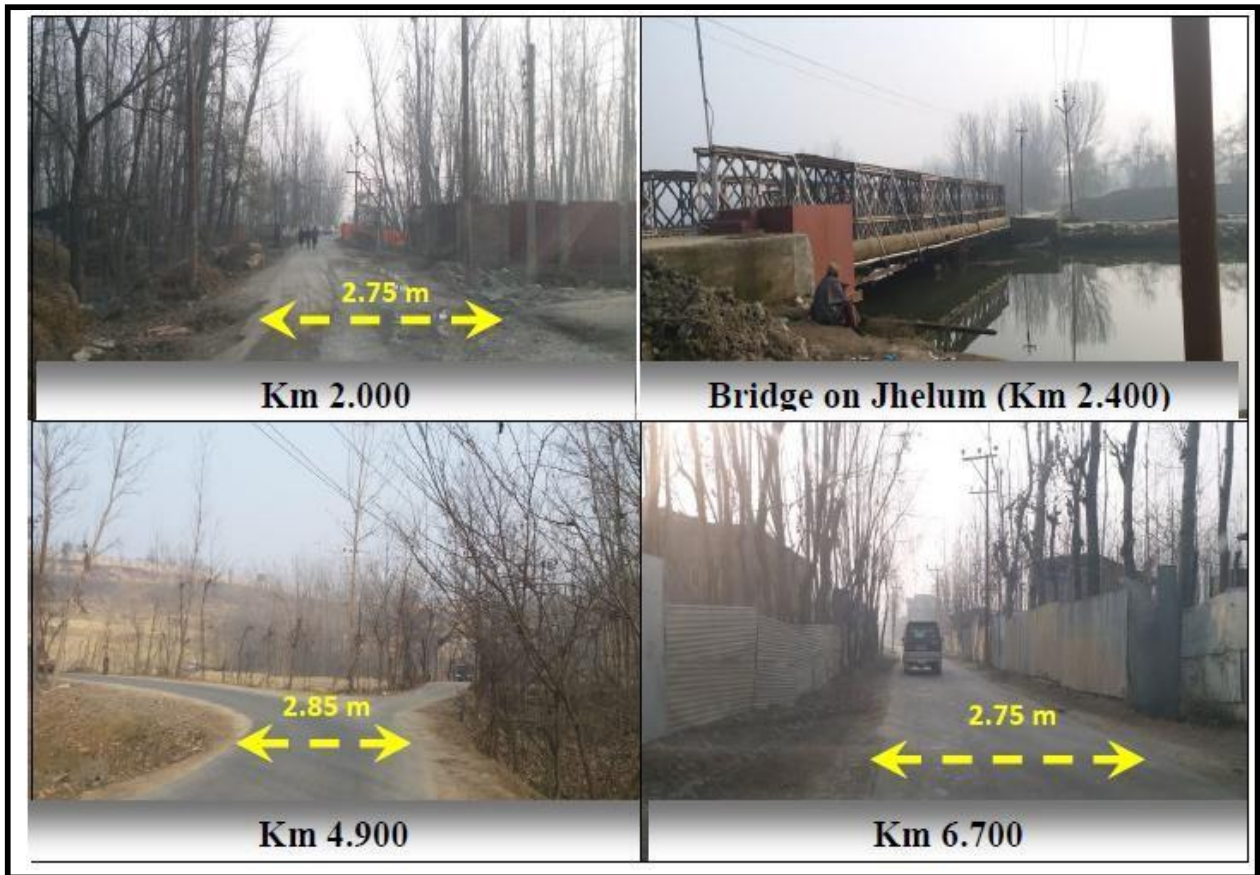
- The pavement was **flexible** and in **poor condition**, showing signs of **longitudinal cracks, crocodile cracks, edge failure, and potholes**. The top layer of bituminous pavement is significantly damaged along the stretch.
- **Milling/ dismantling** of the top 50 mm layer in some stretches was necessary before laying a new base course and bituminous layers.

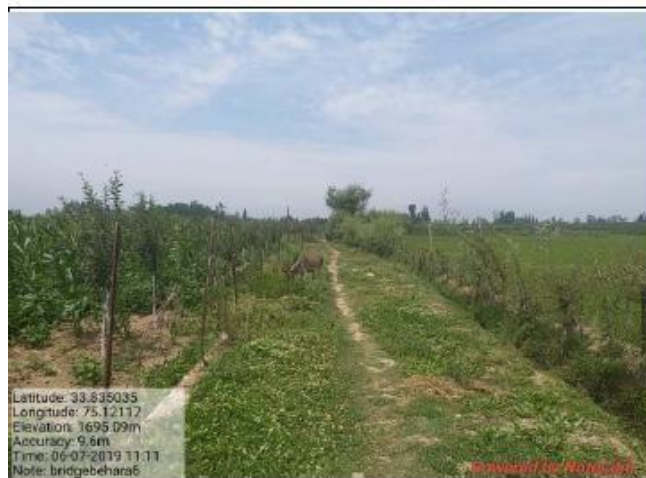
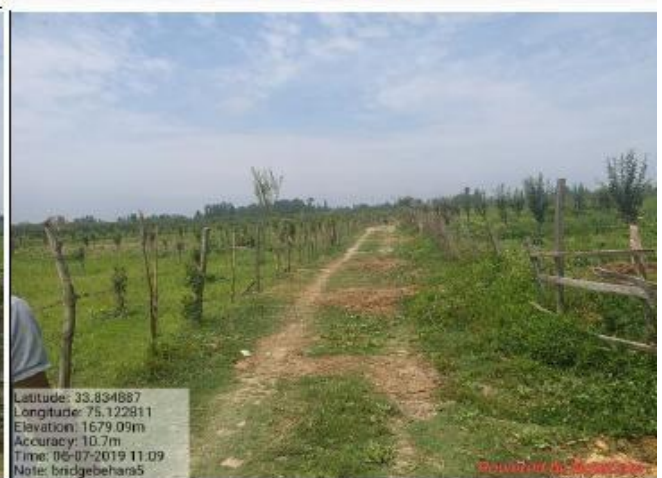
**FOOT TRACK ALIGNMENT (MR)**
