SUB-PROJECT COMPLETION REPORT

“JHELUM TAWI FLOOD RECOVERY PROJECT”

RECONSTRUCTION OF ROADS & BRIDGES

VOLUME – III (BRIDGES)

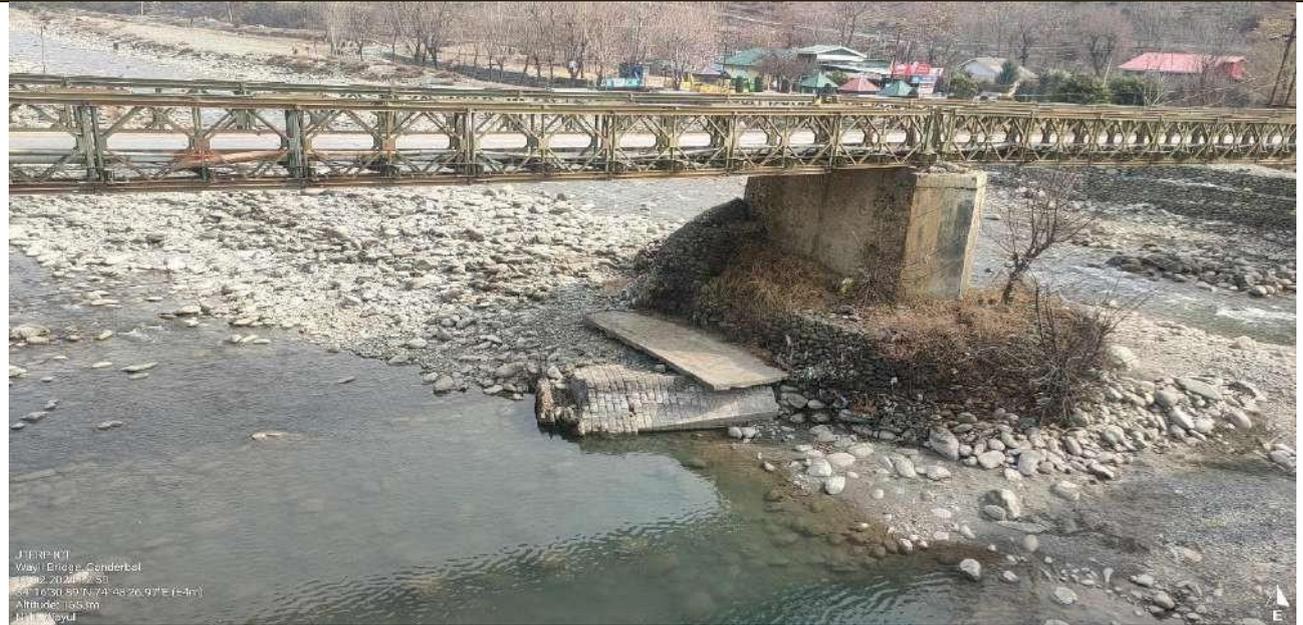
Image illustrating the damaged abutment and deteriorated structural condition of the existing Bailey bridge.

- **Bridge Condition:** The existing Steel Bailey Bridge was in fair to poor condition, showing deterioration in several structural components such as corroded panels, damaged decking, and loose or missing bolts. The bearings and approach slabs

were also in distress, affecting the overall stability of the bridge. The bridge condition deteriorated further after the 2014 floods, which caused significant scouring and alignment issues, leading to prolonged disruption of connectivity to nearby villages.

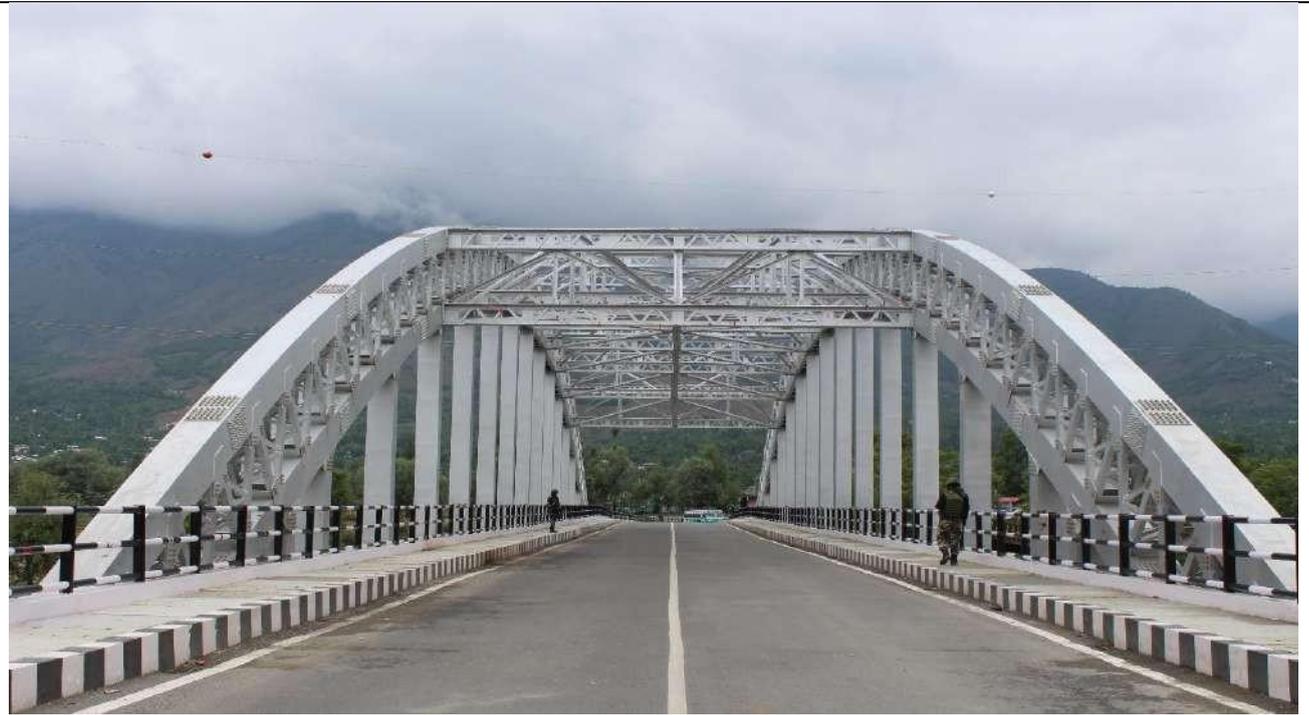
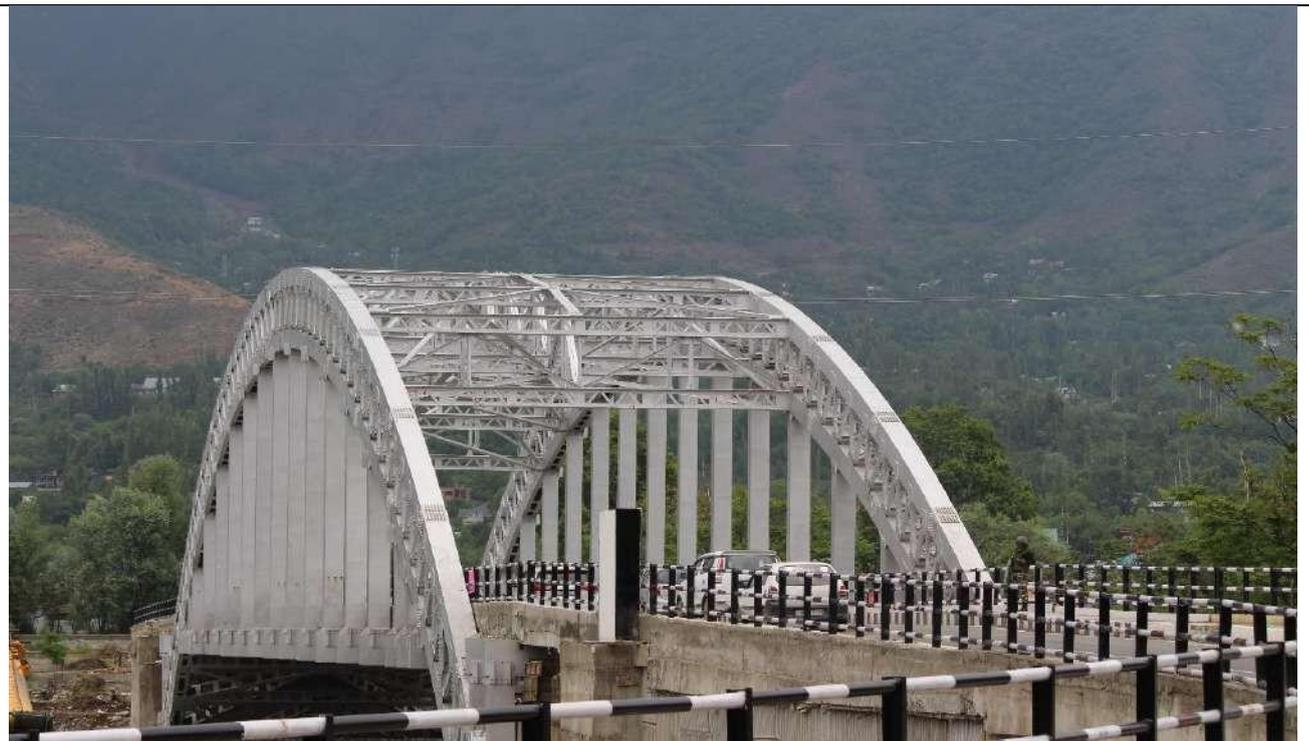
Views of the Wayil Bridge superstructure showing the composite Semi arch steel truss system, longitudinal girders, deck slab, top bracing, Bituminous top, and footpaths.

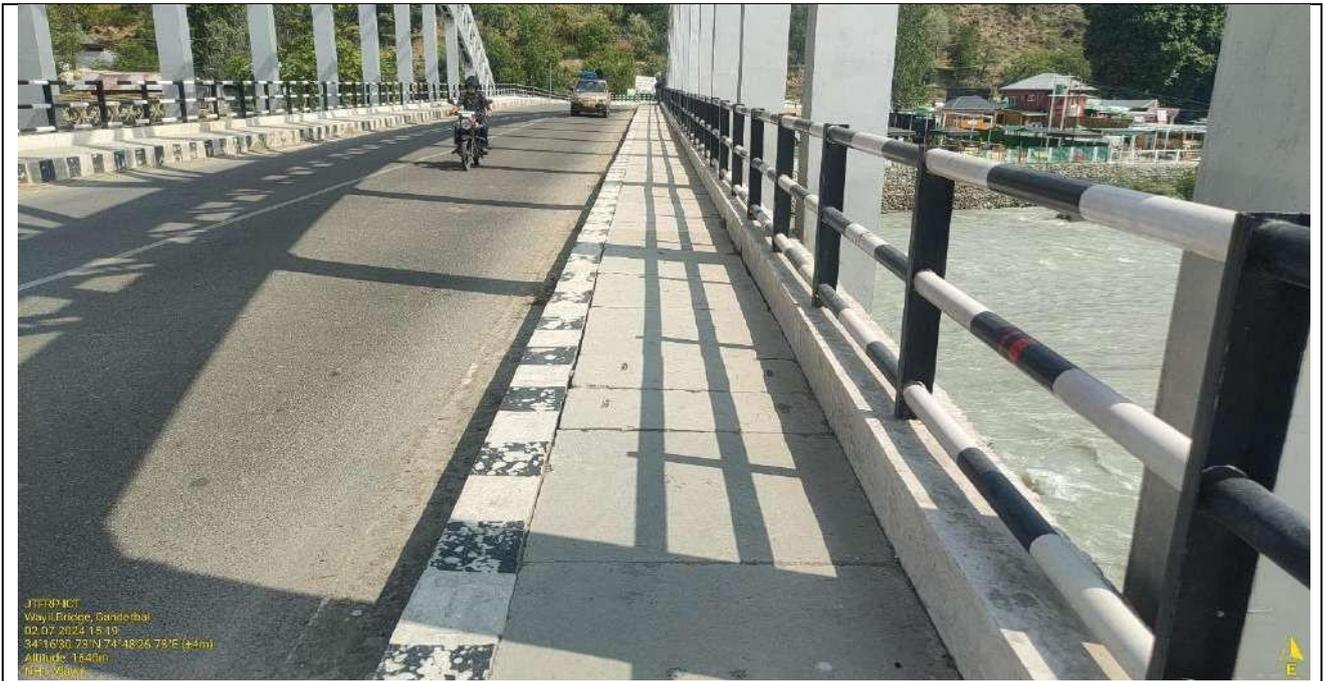
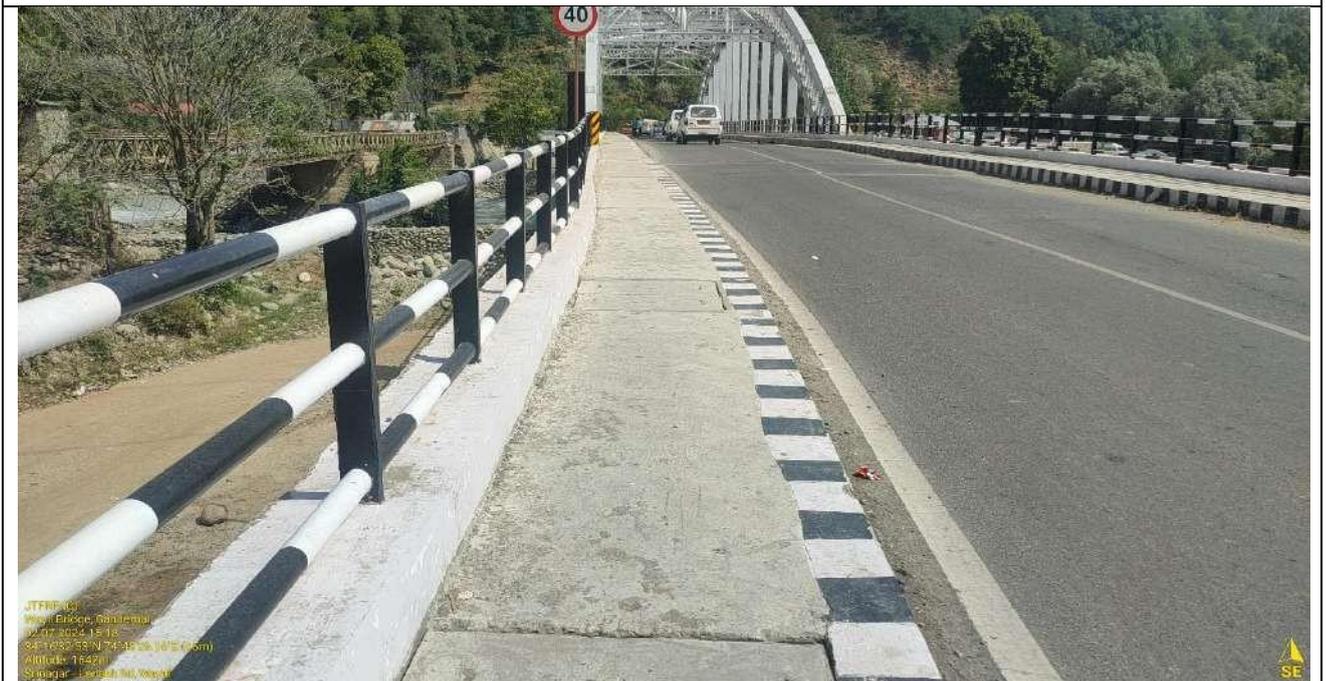
A view of 1.50m wide footpath on both sides of the Wayil bridge

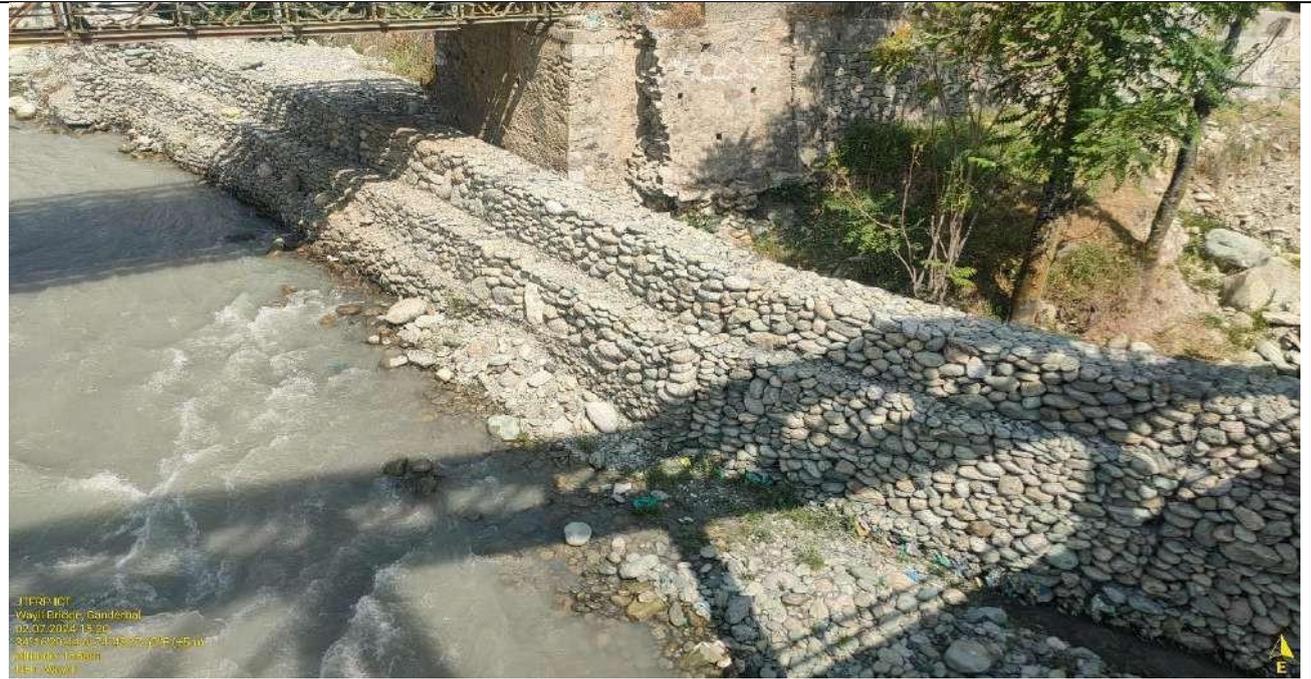
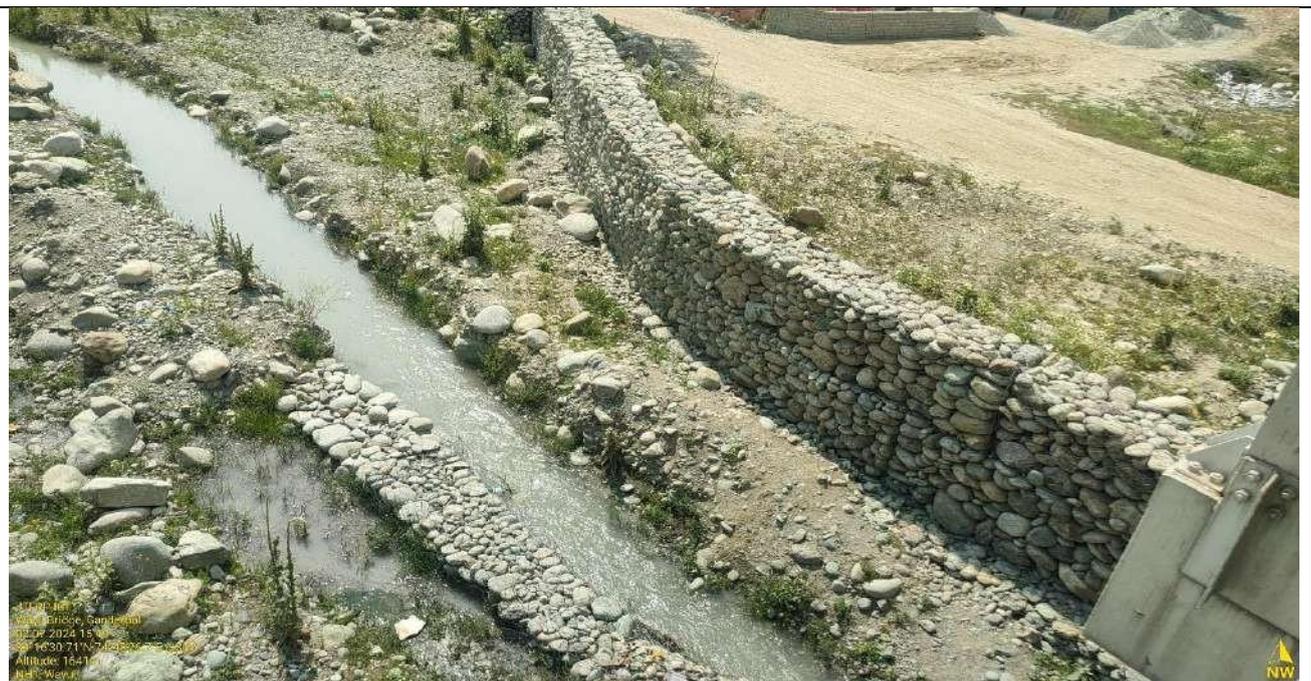
Views of Gabion walls constructed along the upstream and downstream extents of the Wayil Bridge, illustrating the application of gabion structures for effective riverbank stabilization and slope protection.

Along the gabion wall, the Zamindari Canal has been constructed to divert a portion of the Sindh River flows for irrigation purposes, thereby providing direct irrigation benefits to the local farming communities.

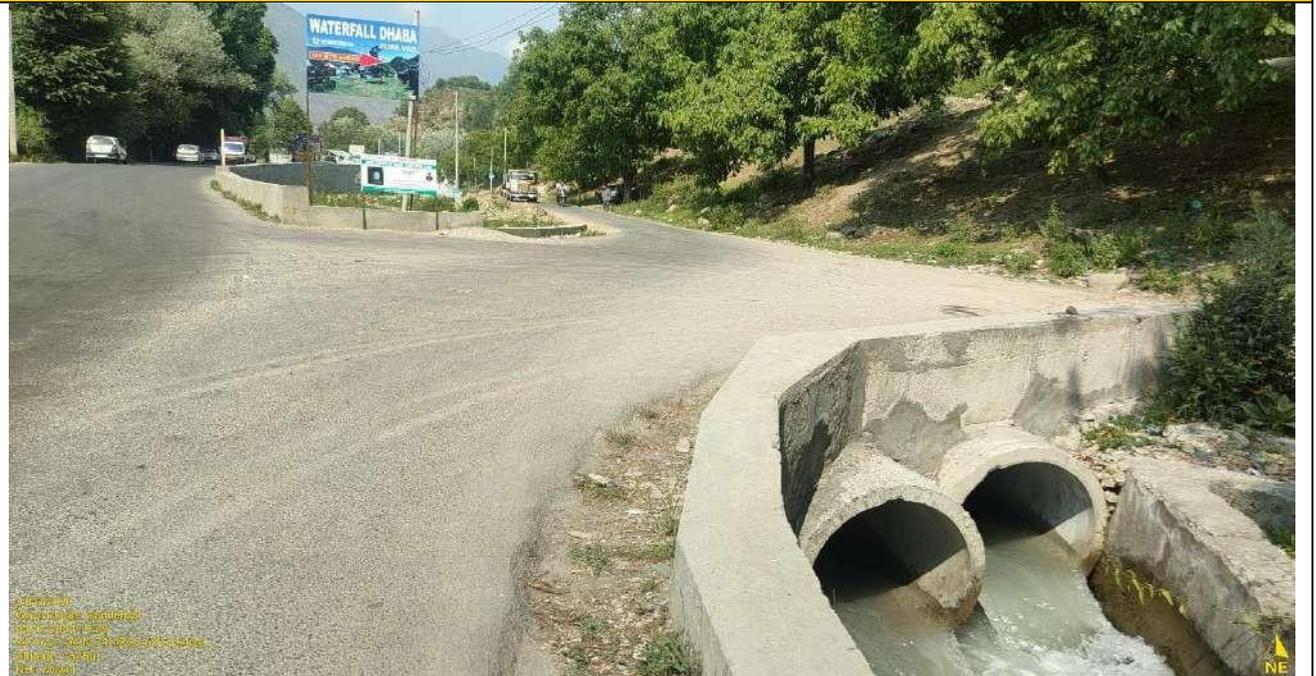
Two NP4 Hume pipe culverts of 1000 mm diameter was installed across the approach road towards Ganderbal, having lengths of 20 m. These culverts were provided to improve water runoff management and facilitate the smooth passage of irrigation water across the road, thereby serving the adjoining paddy fields.

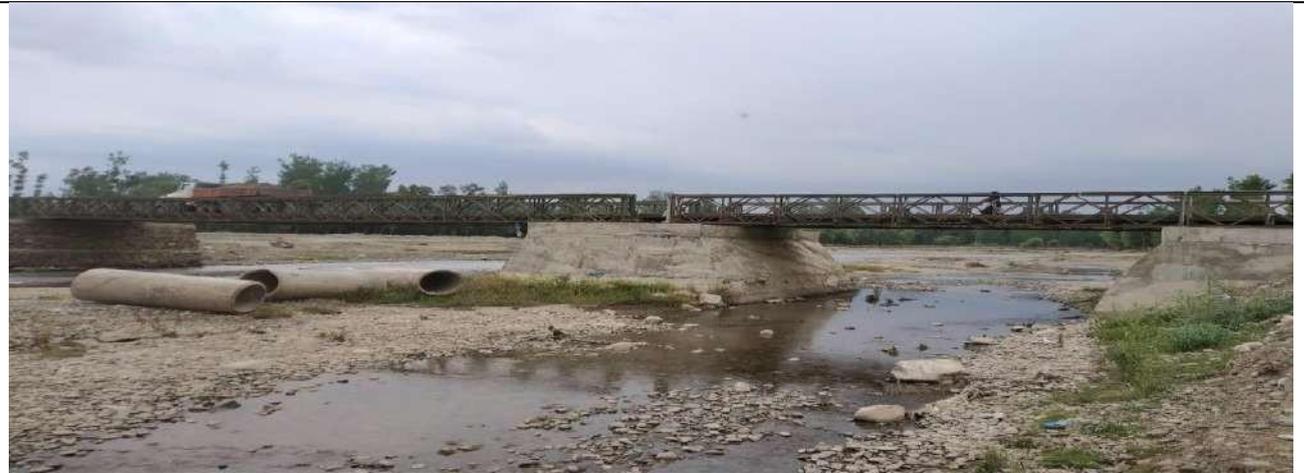
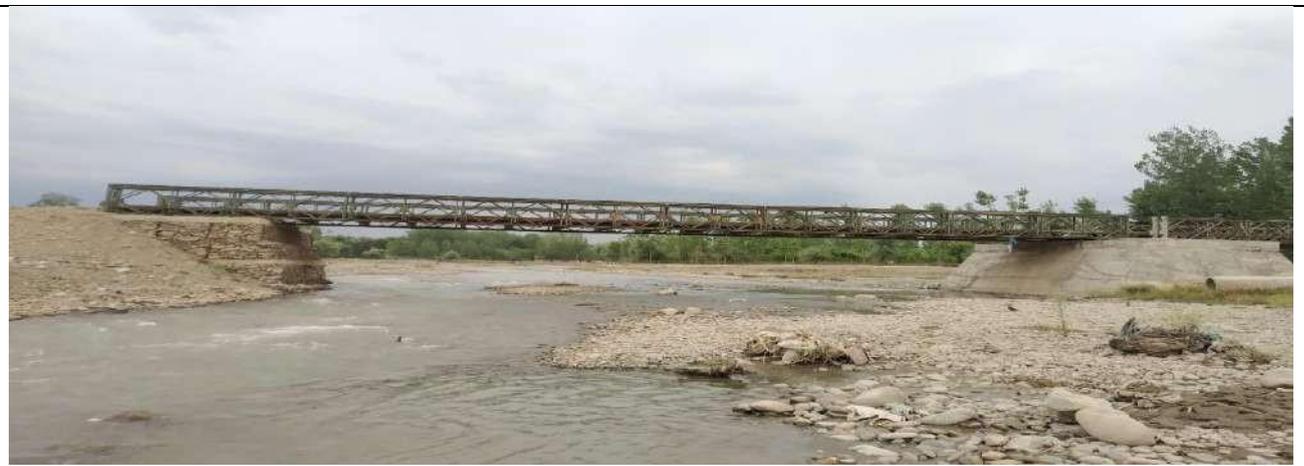
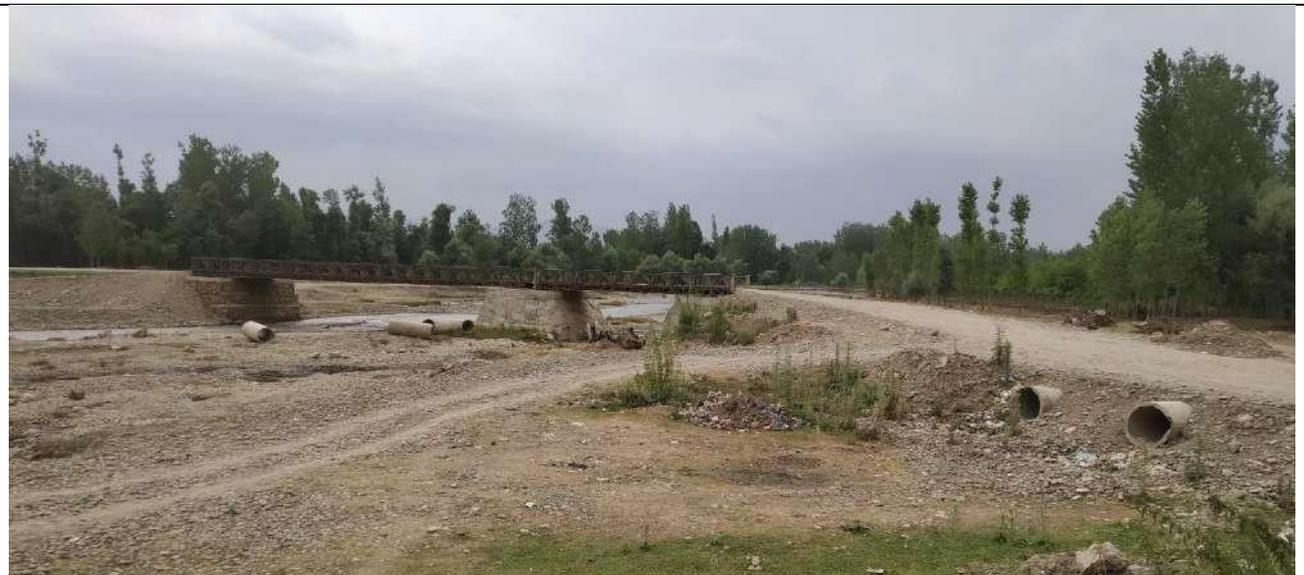
Views of the temporary Bailey bridge and vented causeway installed on the RHS of the newly constructed permanent bridge at Sadoora, Anantnag. This provisional structure, erected post-2014 floods to restore critical connectivity, sustained multiple instances of damage from recurring high flows and required repeated repairs.

To provide a permanent and reliable solution, the construction of a 3 × 30 meter Steel Truss Girder Bridge with deck over Bringi Nallah was constructed, including the associated approach roads and Nallah training works. This project aims to ensure all-weather connectivity for the residents and address the long-pending public demand for a durable crossing structure in the area.

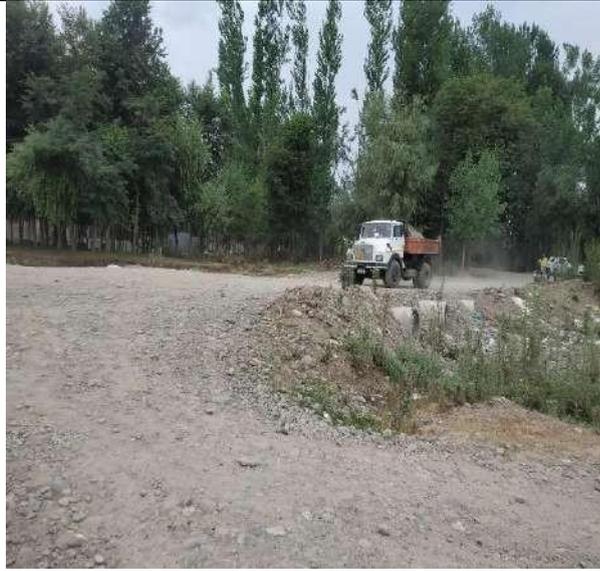
Condition of Approach Road from Sadoora side prior to construction.

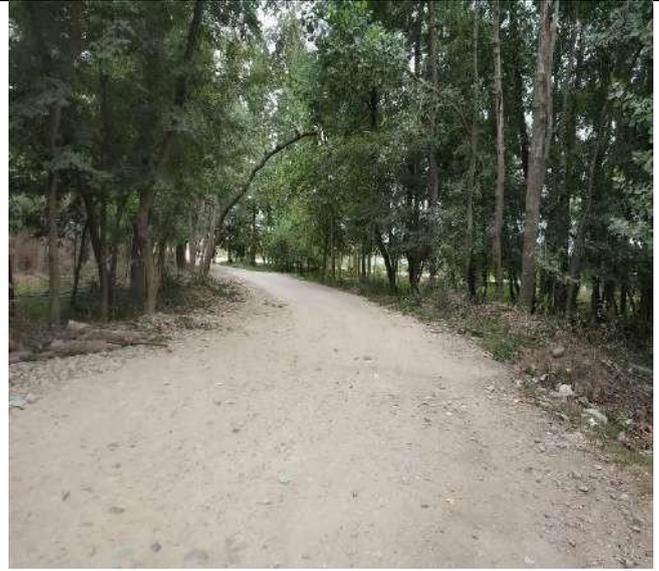
Condition of Approach Road from the Kamad side prior to construction.

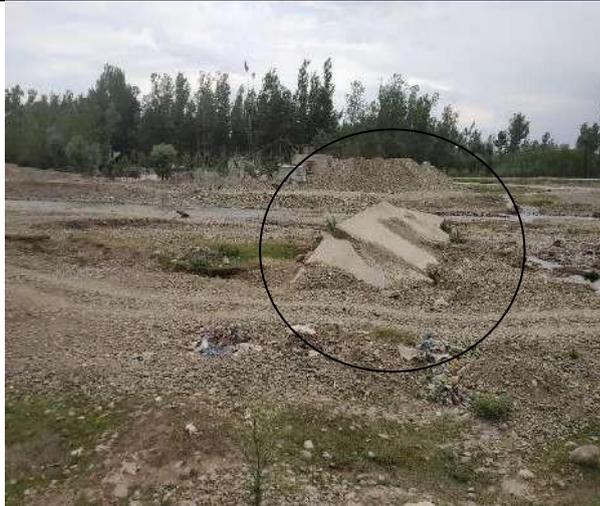
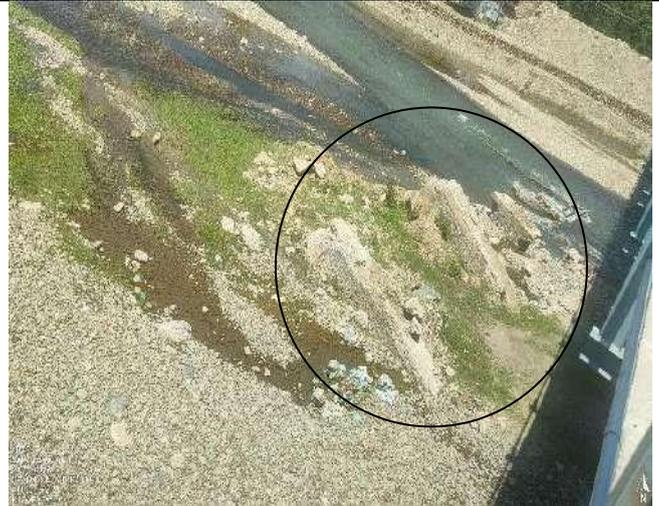
Views of remnants from the previously damaged Sadoora Bridge at Anantnag, illustrating the extensive structural deterioration and debris left by recurrent flooding events prior to the JTFRP reconstruction efforts

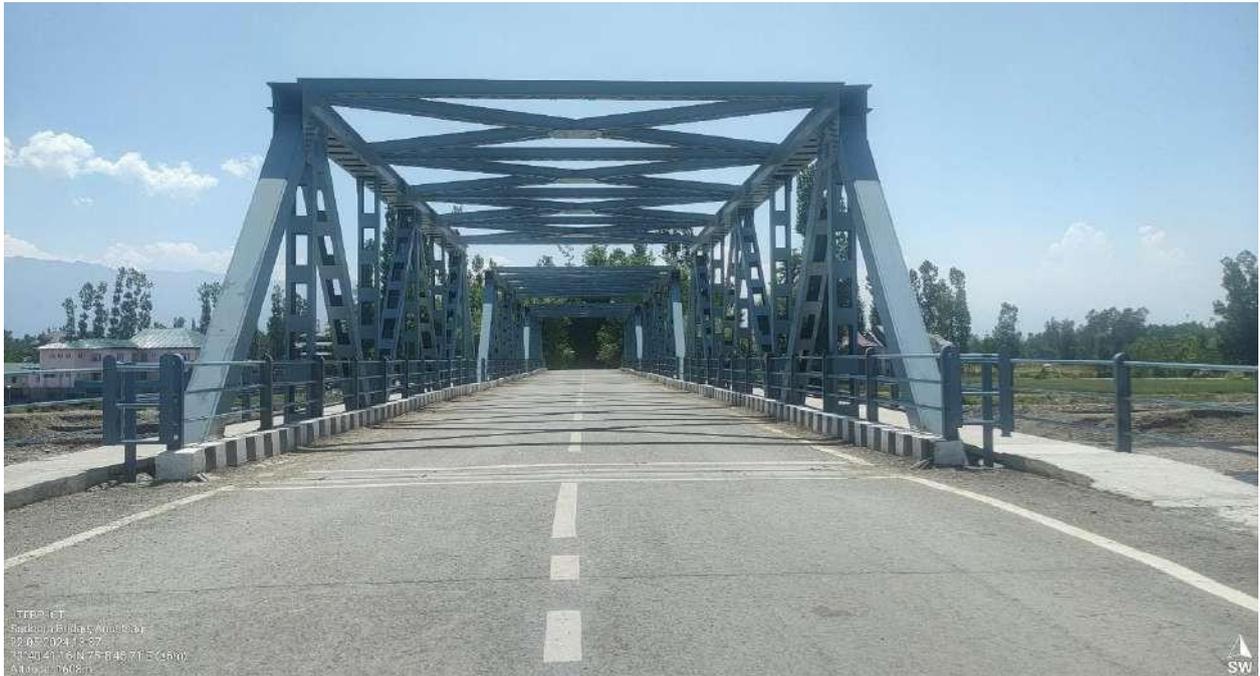
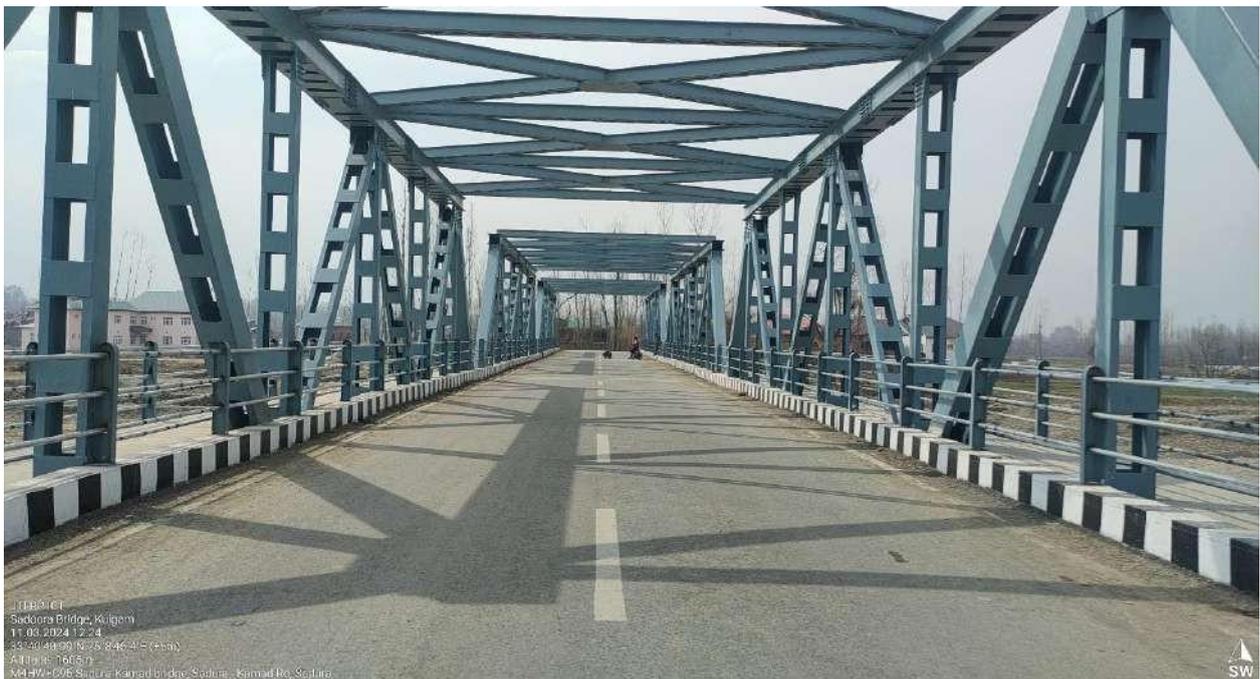
A view of the Sadoora Bridge superstructure showing the composite steel truss girder system, longitudinal girders, Bituminous top, and safety wheel guard with steel railing.

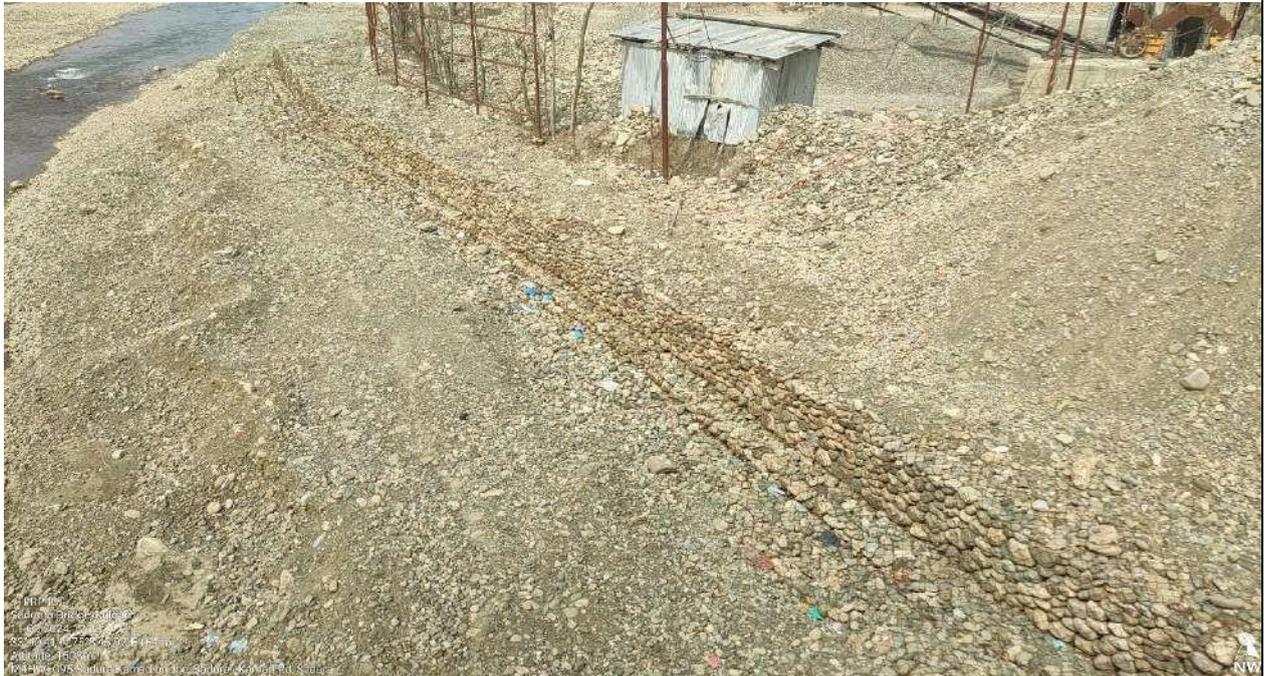
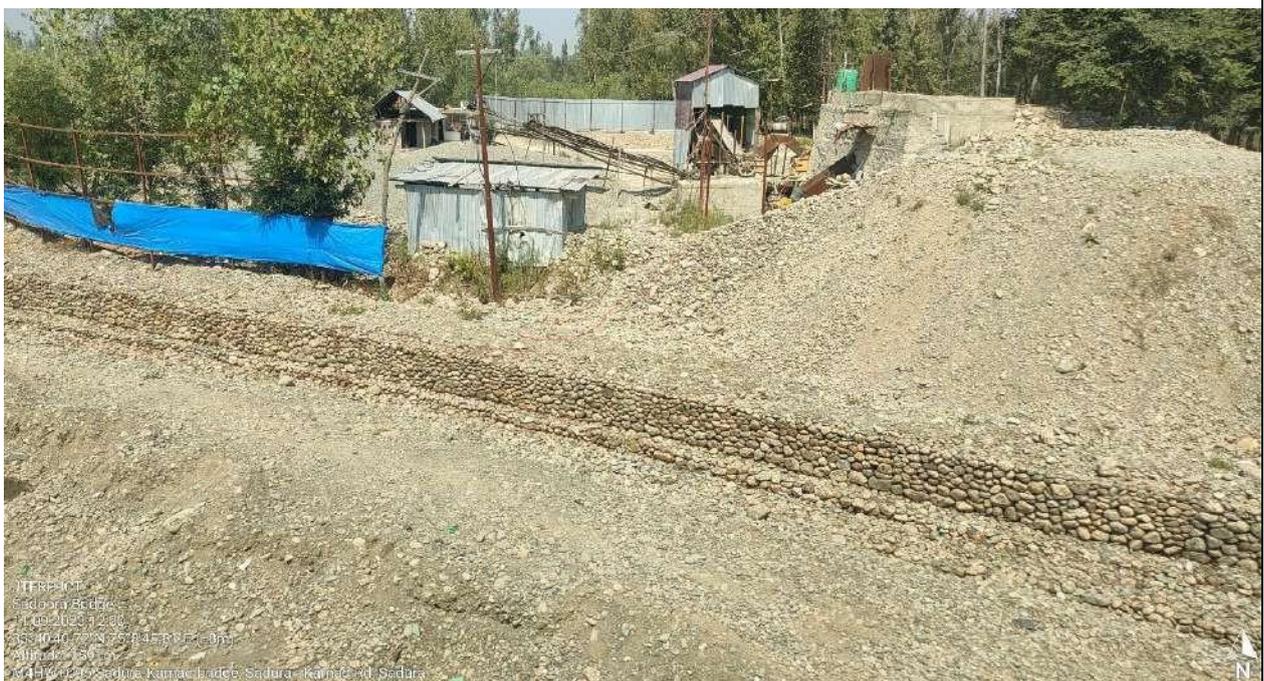
Views of Crate walls constructed along the upstream and downstream extents of the Sadoora Bridge, illustrating the application of crate structures for effective riverbank stabilization and slope protection.

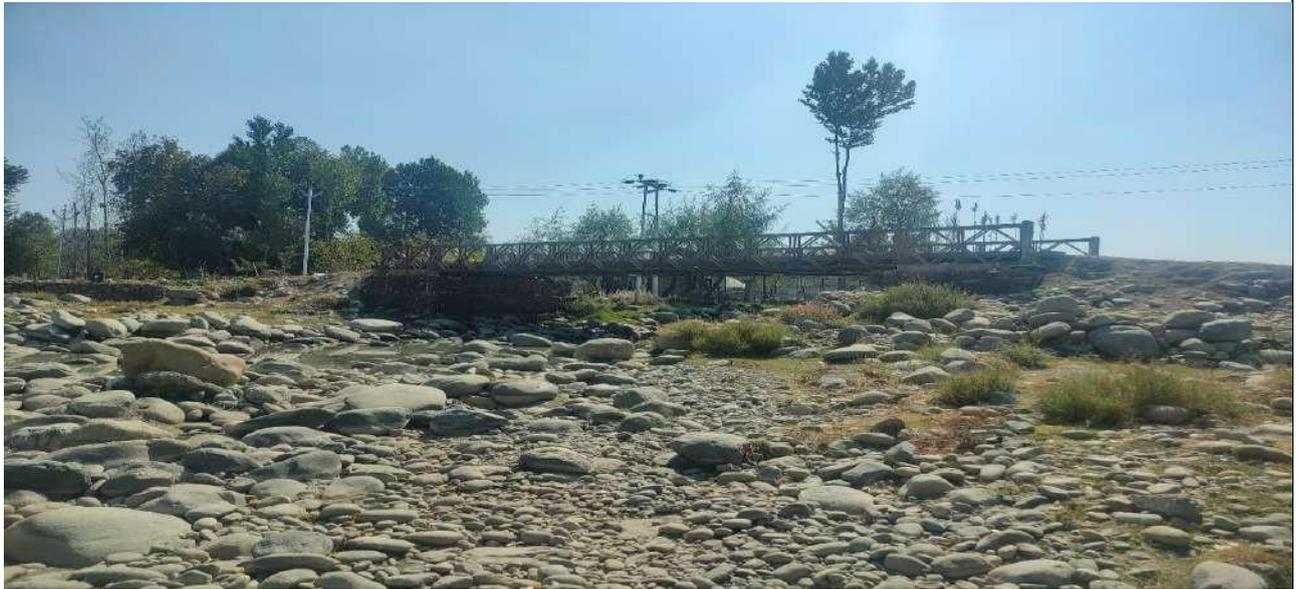
A view of the pre-existing Bailey bridge at the Rohmoo Bridge site, pulwama

In response to these sustainability challenges, JTFRP and the J&K Economic Reconstruction Agency identified the replacement of the bailey bridge with a purpose-designed, permanent steel trussed girder bridge as the optimal solution.

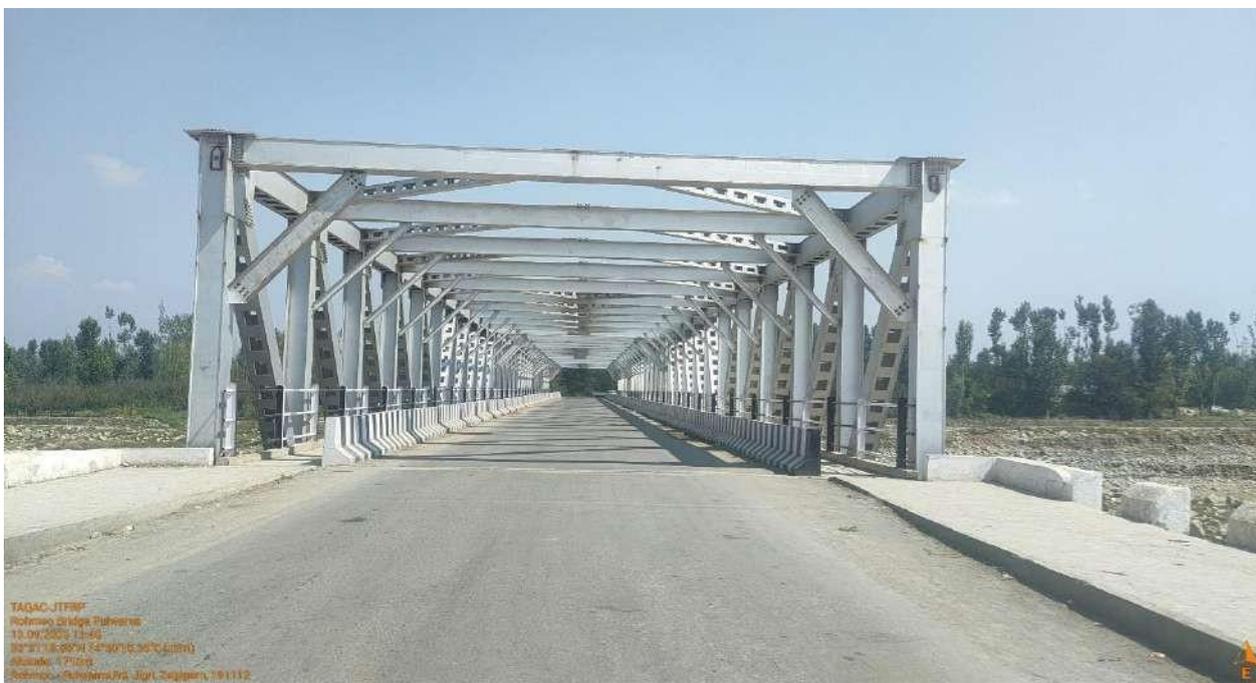
A view of the Rohmoo Bridge superstructure showing the composite steel truss girder system, longitudinal girders, Bituminous top, and safety parapets

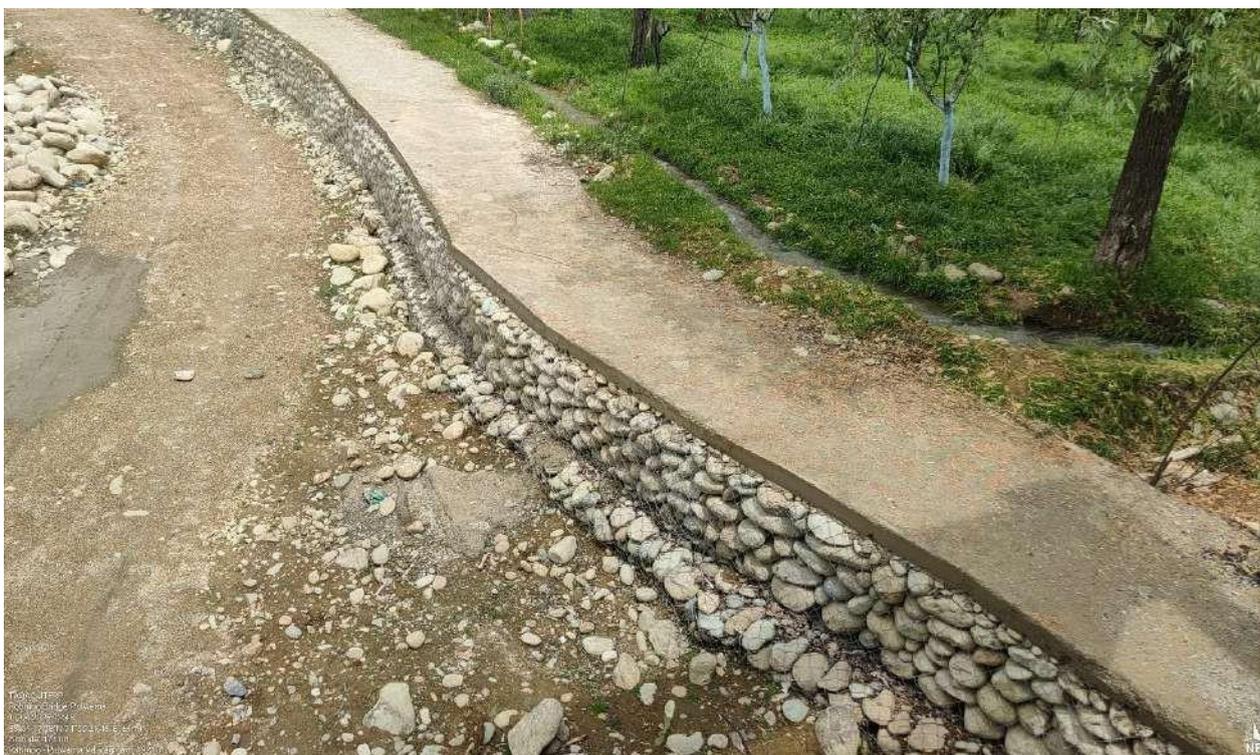
Views of crate walls constructed along the upstream and downstream reaches of the Rohmoo Bridge, demonstrating the use of crate structures for effective riverbank stabilization and slope protection.

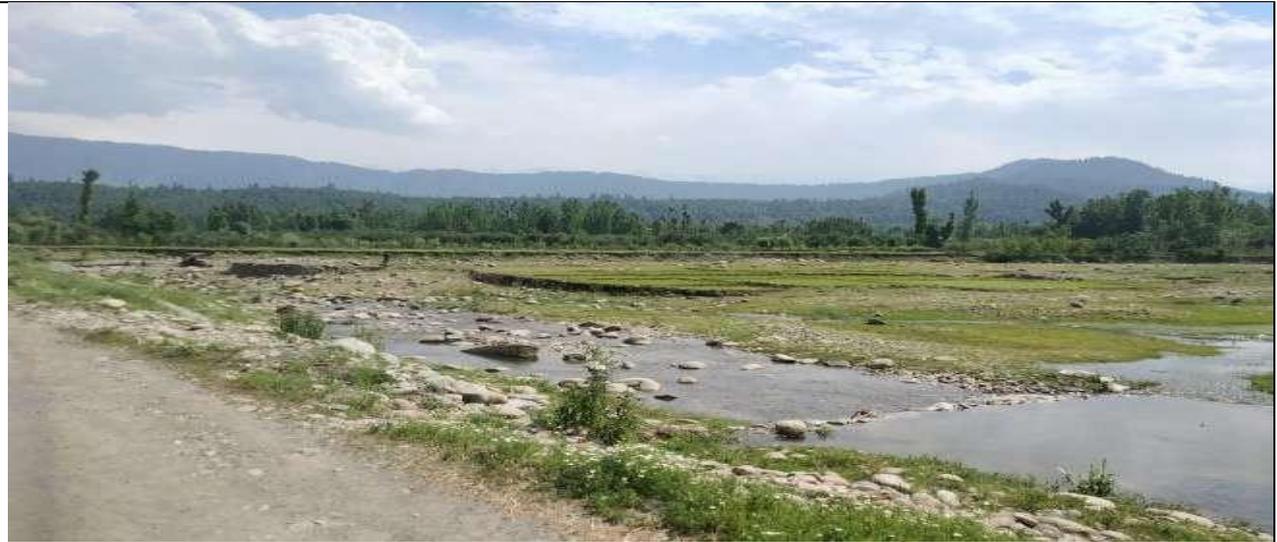
A view of the pre-existing causeway prior to the construction of the resilient Chambgund Bridge at Kulgam.

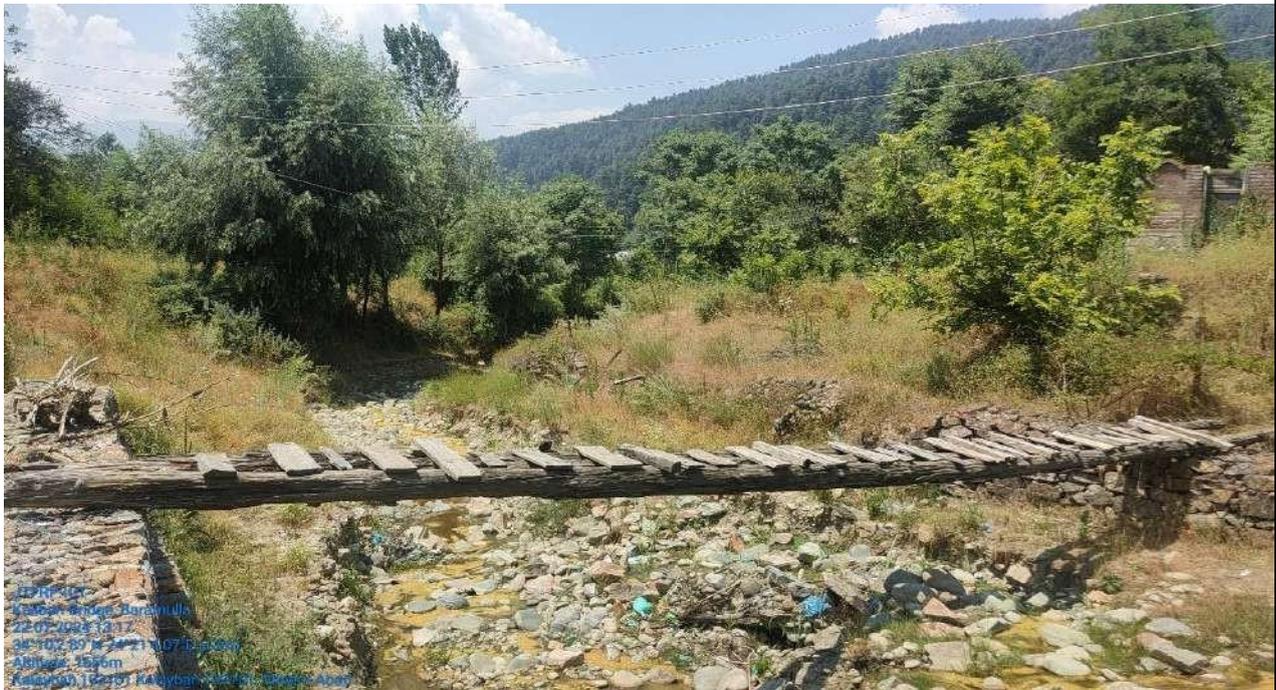
A temporary wooden footbridge was constructed by local residents at the Kaliban Bridge site following the 2014 floods to facilitate stream crossing in the absence of permanent connectivity infrastructure.

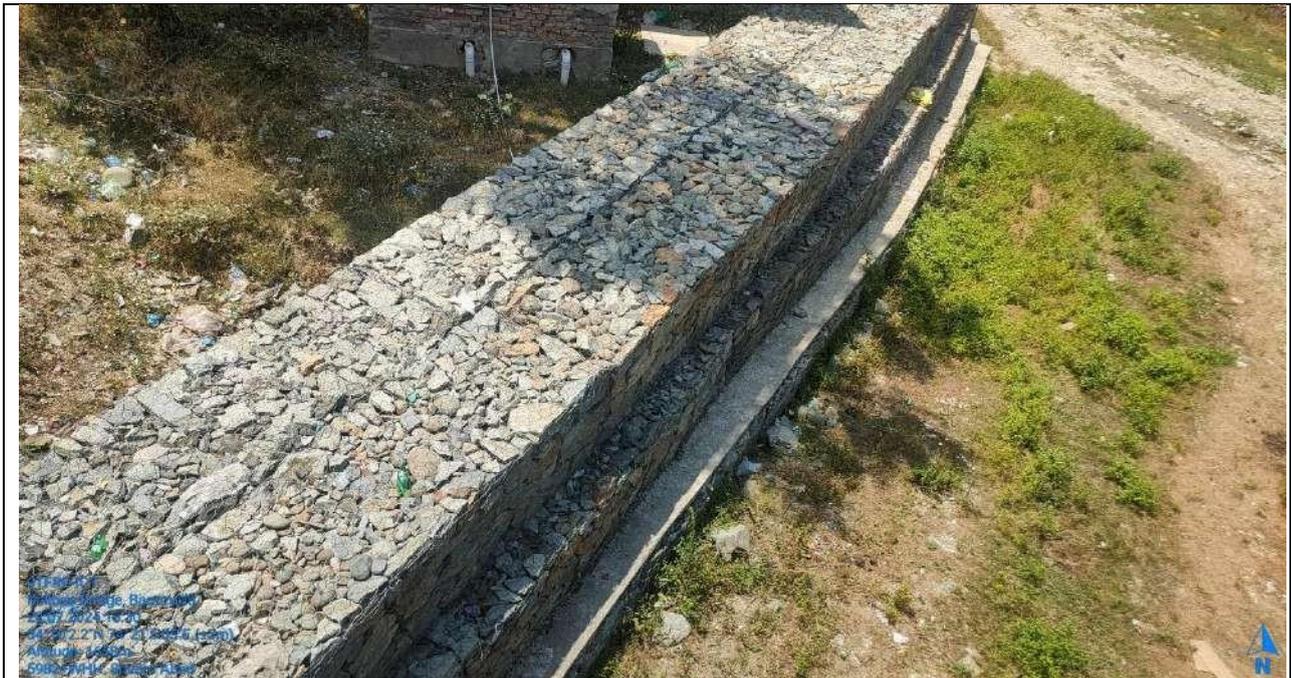
Views of crate walls constructed along the upstream and downstream extents of the Kaliban Bridge, illustrating the application of crate structures for effective riverbank stabilization and slope protection.

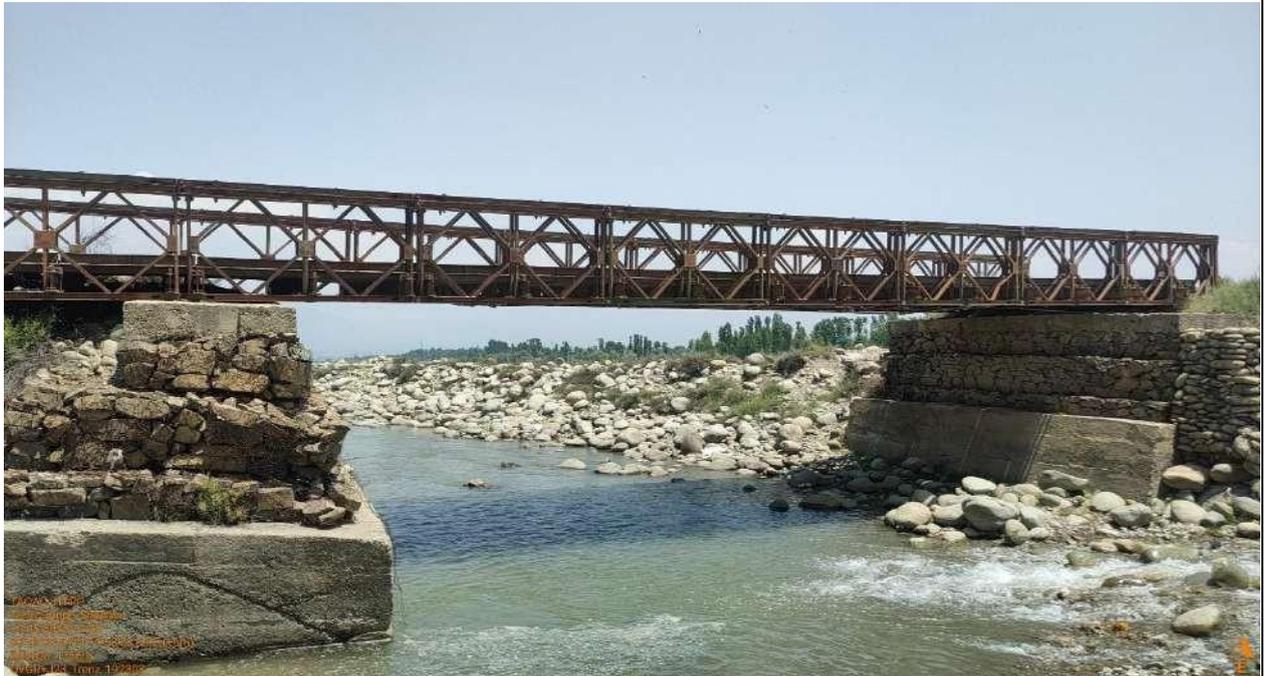
A view of two short span bailey bridges that were existing before the construction of the new Trenz Bridge, Shopian

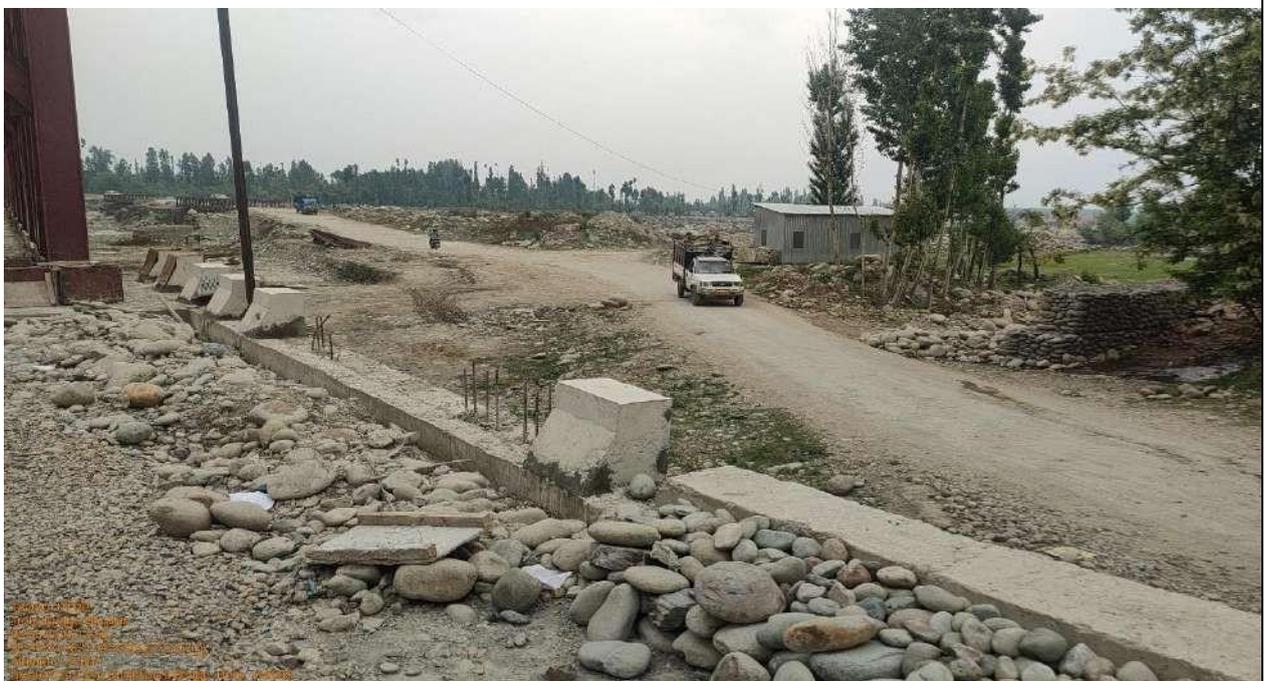
A view of the vented causeways that were existing during the construction of the new Trenz Bridge, Shopian

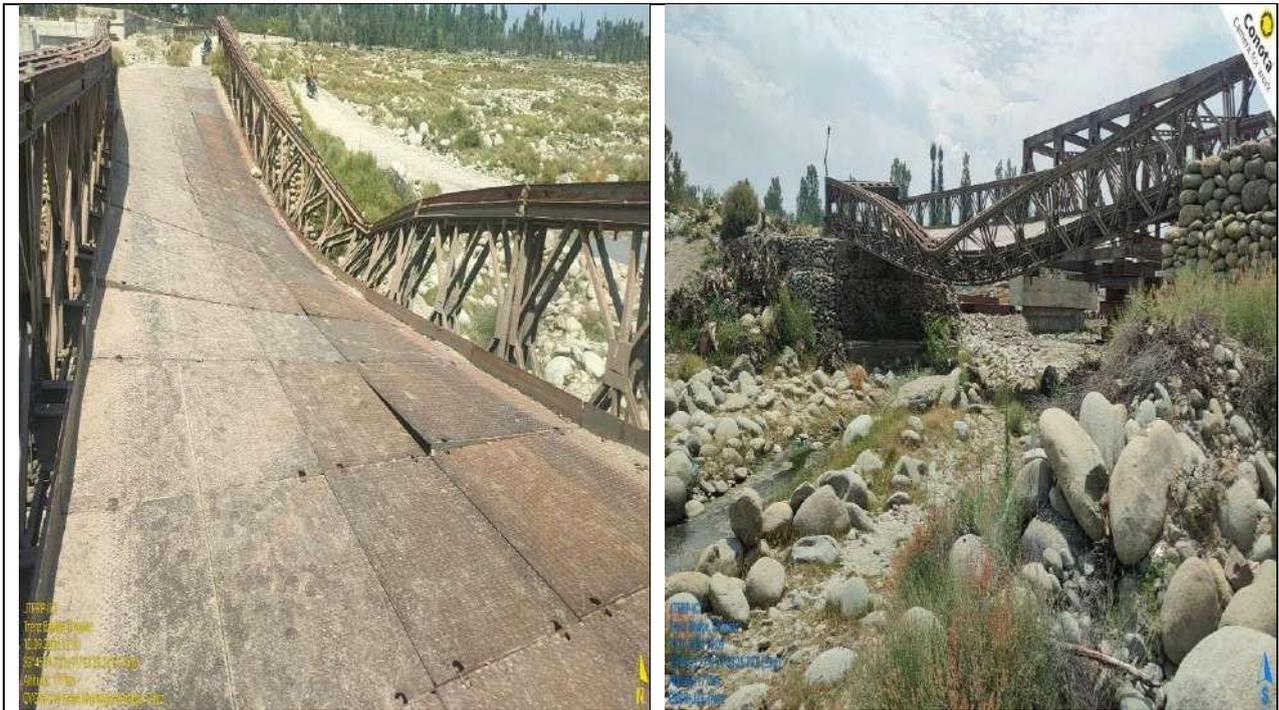
Photograph showing the damaged Bailey bridge at Trenz, affected by flash floods prior to the construction of the new resilient bridge.
