SUB-PROJECT COMPLETION REPORT

“JHELUM TAWI FLOOD RECOVERY PROJECT”

RECONSTRUCTION OF ROADS & BRIDGES

VOLUME – III (BRIDGES)

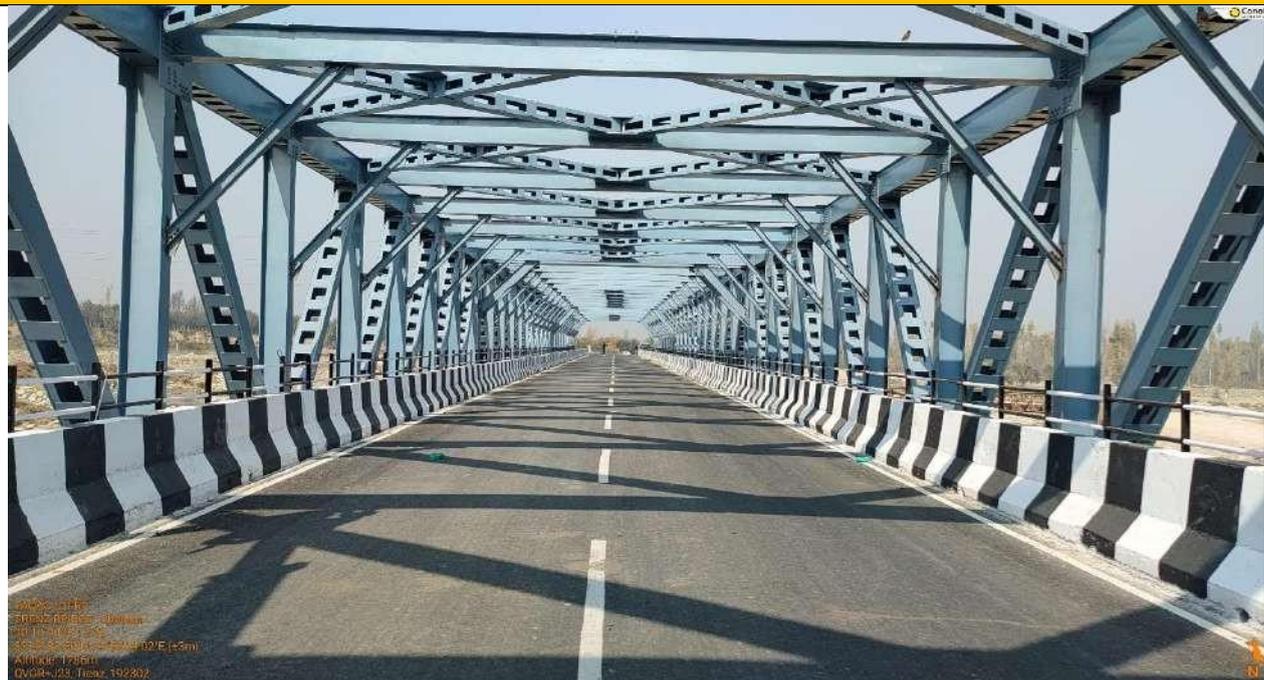
A view of the Trenz Bridge superstructure showing the composite steel truss arch system, longitudinal girders, deck slab, cross-girders, Bituminous top, and safety parapets.

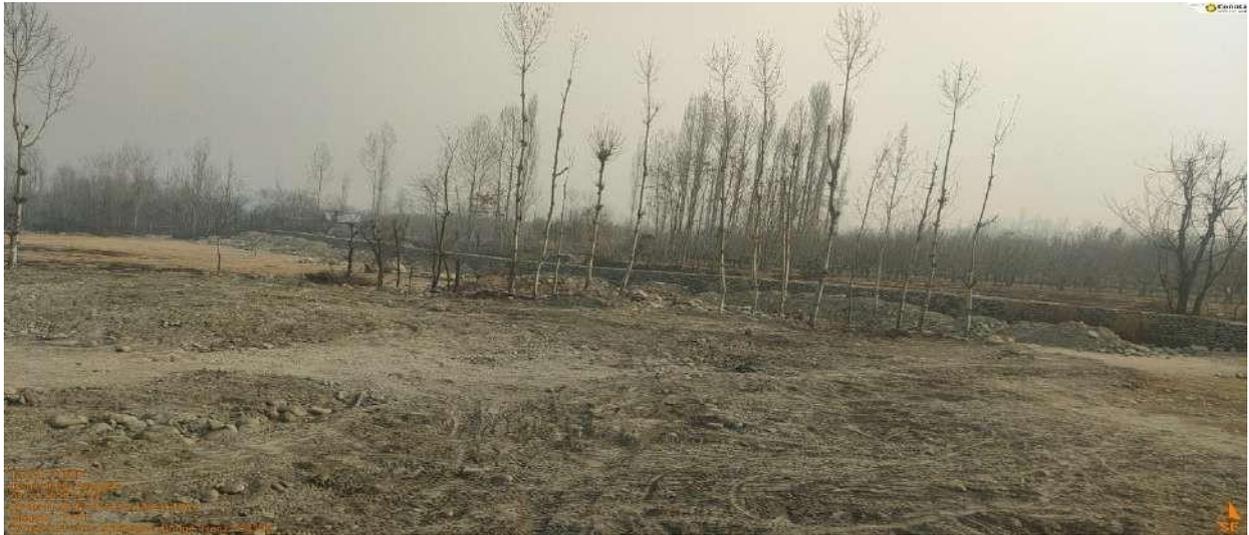
All existing causeway and Bailey bridge combinations at the Trenz Bridge site were dismantled and demolished in accordance with the Environmental Management Plan (EMP) guidelines as part of the post-construction activities.
